# Manhole Inspection Summary

Manhole # S07AA2017MH

**Location** Address: **2800 CROSS COUNTRY BLVD** Cross Street: **WESTERN RUN DR**

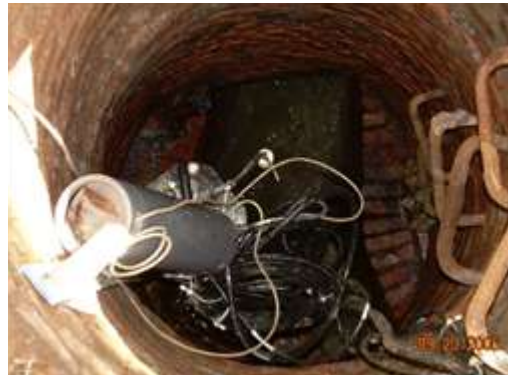
Top View

Adjustment and Corbel infiltration.  
Evidence of surcharge - Bench debris.  
Corroded steps.
